Work Order ID 138027***138027***

Item ID: D206-667-147TRN

Item Name: Crosstube Assembly, Mid Fwd

Work Order: <u>138027</u> Part No. <u>D206-667-147TRN</u> NCR No. <u>15-5412</u>		DISPOSITION Rework ☐ Scrap ☐ Use-as-is ☒ Suspected Unapproved ☐		AGAINST DEPARTMENT/PROCESS <table style="width:100%;"> <tr> <td>Skid-tube ☐</td> <td>Cross tube ☒</td> <td>Water Jet ☐</td> <td>Engineering ☐</td> </tr> <tr> <td>Machining ☐</td> <td>Small Fab ☐</td> <td>Prod. Eng. Coord. ☐</td> <td>Quality ☐</td> </tr> <tr> <td>Thermoforming ☐</td> <td>Finishing ☐</td> <td>Rec/Store/Packaging ☐</td> <td>Other ☐</td> </tr> <tr> <td>Large Fab ☐</td> <td>Composite ☐</td> <td>Supplier ☐</td> <td></td> </tr> </table>				Skid-tube ☐	Cross tube ☒	Water Jet ☐	Engineering ☐	Machining ☐	Small Fab ☐	Prod. Eng. Coord. ☐	Quality ☐	Thermoforming ☐	Finishing ☐	Rec/Store/Packaging ☐	Other ☐	Large Fab ☐	Composite ☐	Supplier ☐																																																	
Skid-tube ☐	Cross tube ☒	Water Jet ☐	Engineering ☐

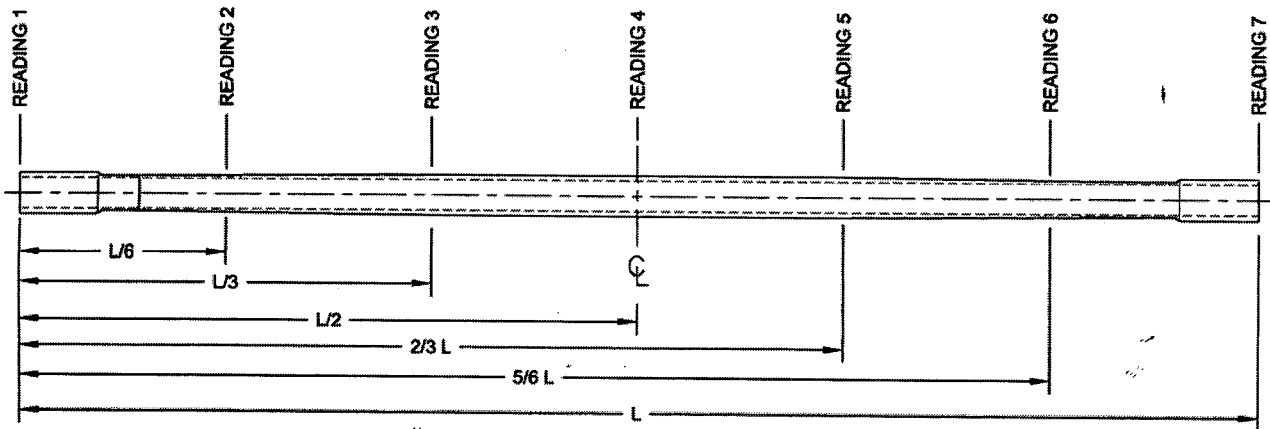
Machining ☐	Small Fab ☐	Prod. Eng. Coord. ☐	Quality ☐																																																																				
Thermoforming ☐	Finishing ☐	Rec/Store/Packaging ☐	Other ☐																																																																				
Large Fab ☐	Composite ☐	Supplier ☐																																																																					
Date: <u>15/10/26</u>		Step #:		QTY Effective: <u>1</u>		MRB (QSI042) Approval DAS 12 15/10/26 9-89																																																																	
Description Work Order Deviation Well thickness measurement is over tolerance. Min well: 0.234 Dwg = 0.240 Δ - 0.002				Disposition Min well is within allowable of raw mat'l. Acceptable.				Completed By DAS 12 15/10/26 9-89 Lead hand / Supervisor Approval 47 9-89 15-10-28																																																															
Root Cause <table style="width:100%;"> <tr> <td>Environment ☐</td> <td>No Re-verification ☐</td> </tr> <tr> <td>Design ☐</td> <td>Operator ☐</td> </tr> <tr> <td>Doc/Data ☐</td> <td>Offset/Setup ☐</td> </tr> <tr> <td>Equip/Tooling ☐</td> <td>Supplier ☐</td> </tr> <tr> <td>Handling/Pre ☐</td> <td>Training ☐</td> </tr> <tr> <td>Material ☒</td> <td>Use for Testing ☐</td> </tr> <tr> <td>Internal Transport ☐</td> <td>Poor Information ☐</td> </tr> <tr> <td>Tribal Knowledge ☐</td> <td>Rushing ☐</td> </tr> <tr> <td>LOA ☐</td> <td>Product Improvement ☐</td> </tr> <tr> <td>Substation ☐</td> <td>Process Improvement ☐</td> </tr> <tr> <td>Past Expiry Date ☐</td> <td>Manufacturing Process ☐</td> </tr> <tr> <td>Misidentified ☐</td> <td>Past Due ☐</td> </tr> </table>				Environment ☐	No Re-verification ☐	Design ☐	Operator ☐	Doc/Data ☐	Offset/Setup ☐	Equip/Tooling ☐	Supplier ☐	Handling/Pre ☐	Training ☐	Material ☒	Use for Testing ☐	Internal Transport ☐	Poor Information ☐	Tribal Knowledge ☐	Rushing ☐	LOA ☐	Product Improvement ☐	Substation ☐	Process Improvement ☐	Past Expiry Date ☐	Manufacturing Process ☐	Misidentified ☐	Past Due ☐	FAULT CATEGORY <table style="width:100%;"> <tr> <td>Pressure/Forced ☐</td> <td>Temperature/Cure ☐</td> <td>Power Loss/Surge ☐</td> <td>Positioned Wrong ☐</td> </tr> <tr> <td>Bending ☐</td> <td>Set-up ☐</td> <td>Folio/Program ☐</td> <td>Outside Dimensions ☐</td> </tr> <tr> <td>☒ Centre Not Concentric</td> <td>BOM/Route ☐</td> <td>Grain ☐</td> <td>☒ Over/Under tolerance</td> </tr> <tr> <td>Cracks ☐</td> <td>Broken/Damage/Defect ☐</td> <td>Weld ☐</td> <td>Part Incorrect ☐</td> </tr> <tr> <td>Crimp/Kink/Ripple/Wave ☐</td> <td>Inspection Incomplete/Unqualified ☐</td> <td>Wrong Stock Pulled ☐</td> <td>Part Lost/Missing ☐</td> </tr> <tr> <td>Cuffs ☐</td> <td>Contamination ☐</td> <td>Out of Sequence ☐</td> <td>Part Moved ☐</td> </tr> <tr> <td>Crushing ☐</td> <td>Countersink ☐</td> <td>Off-set ☐</td> <td>Drawing ☐</td> </tr> <tr> <td>Heat Treat ☐</td> <td>Cut Too Short ☐</td> <td>Mislabeled ☐</td> <td>Finish ☐</td> </tr> <tr> <td>Wave/Twist in Tube ☐</td> <td>Instructions Incomplete/Unclear ☐</td> <td>Fit/Function ☐</td> <td>Misread ☐</td> </tr> <tr> <td>Marks/Chatter ☐</td> <td>Drill Holes ☐</td> <td>Misaligned/off center ☐</td> <td>Turning Sequence ☐</td> </tr> </table>				Pressure/Forced ☐	Temperature/Cure ☐	Power Loss/Surge ☐	Positioned Wrong ☐	Bending ☐	Set-up ☐	Folio/Program ☐	Outside Dimensions ☐	☒ Centre Not Concentric	BOM/Route ☐	Grain ☐	☒ Over/Under tolerance	Cracks ☐	Broken/Damage/Defect ☐	Weld ☐	Part Incorrect ☐	Crimp/Kink/Ripple/Wave ☐	Inspection Incomplete/Unqualified ☐	Wrong Stock Pulled ☐	Part Lost/Missing ☐	Cuffs ☐	Contamination ☐	Out of Sequence ☐	Part Moved ☐	Crushing ☐	Countersink ☐	Off-set ☐	Drawing ☐	Heat Treat ☐	Cut Too Short ☐	Mislabeled ☐	Finish ☐	Wave/Twist in Tube ☐	Instructions Incomplete/Unclear ☐	Fit/Function ☐	Misread ☐	Marks/Chatter ☐	Drill Holes ☐	Misaligned/off center ☐	Turning Sequence ☐

Location	WALL THICKNESS MEASUREMENT (IN)				Deviation Δw (max-min)	TOLERANCE
	w1	w2	w3	w4		
READING 1 L= 0"	.258	.255	.251	.244	.009	0.035"
READING 2 L= 17	.182	.168	.162	.161	.021	
READING 3 L= 33	.253	.246	.238	.276	.038	
READING 4 L= 50	.259	.256	.251	.249	.010	
READING 5 L= 67	.251	.253	.242	.243	.011	
READING 6 L= 83	.181	.177	.164	.175	.017	
READING 7 L= 99	.259	.256	.251	.249	.010
